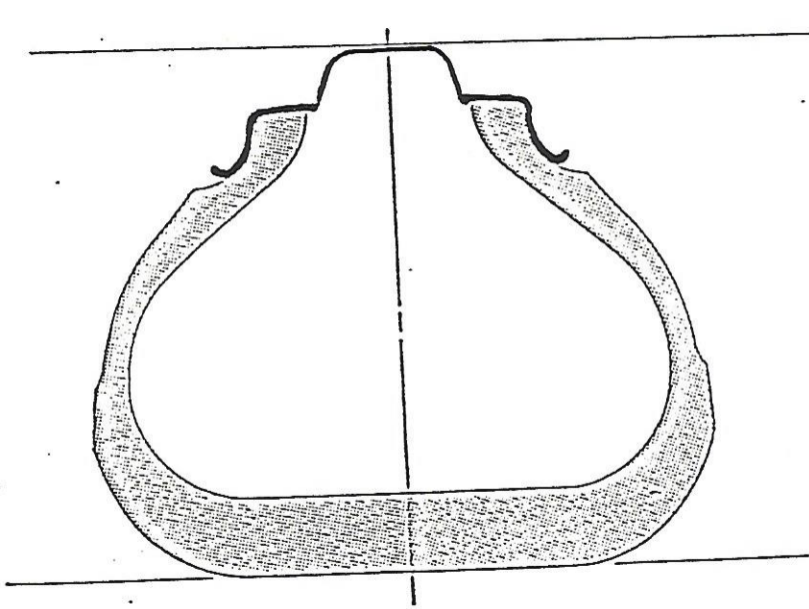
Drawing #1 is from a tire loaded to its maximum capacity and corresponding maximum pressure molded on the sidewall. You can see from the rounded sidewall, the load is evenly distributed over the tread contact patch.

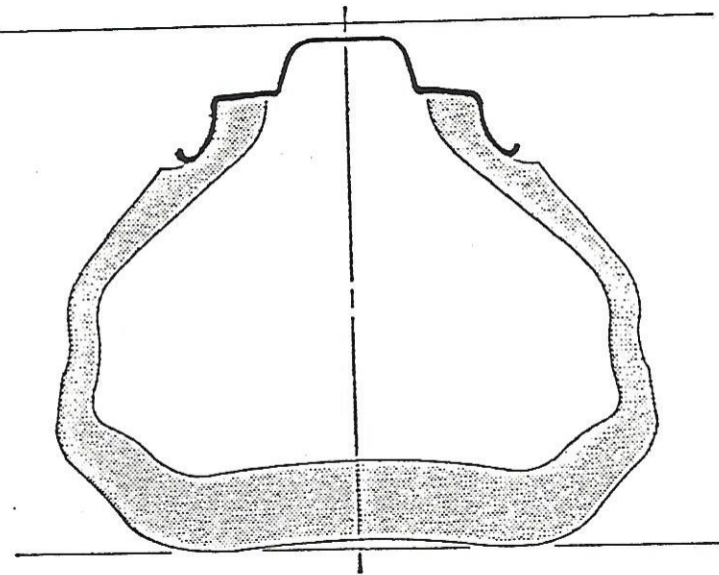
Drawing #2 illustrates the sidewall distortion that occurs when a tire is eight to ten PSI underinflated. The effects can be exaggerated with higher loads and/or lower inflation pressure. The inversion of the tread contact area is somewhat exaggerated for the purpose of illustration, but reflects the results of contact pressure measurements taken across the tread of an underinflated tire. The actual buckling of the tread pattern results in fatigue cracking.

The buckling of the sidewalls cause exterior cracking, and more seriously, the continuous flexing and inversion of the plies can crack the inner most ply and innerliner then migrate outward. The important factor to remember is the repeated compression and relaxation or flex cycles of the upper sidewall generate heat at highway speeds and will rapidly damage the tire. Sudden failure may then occur.
